**Report on
PPG Industries
Nexus to Lower
Passaic River Study
Area**

September 9, 2016
PPG
Project No. 16692.00/001

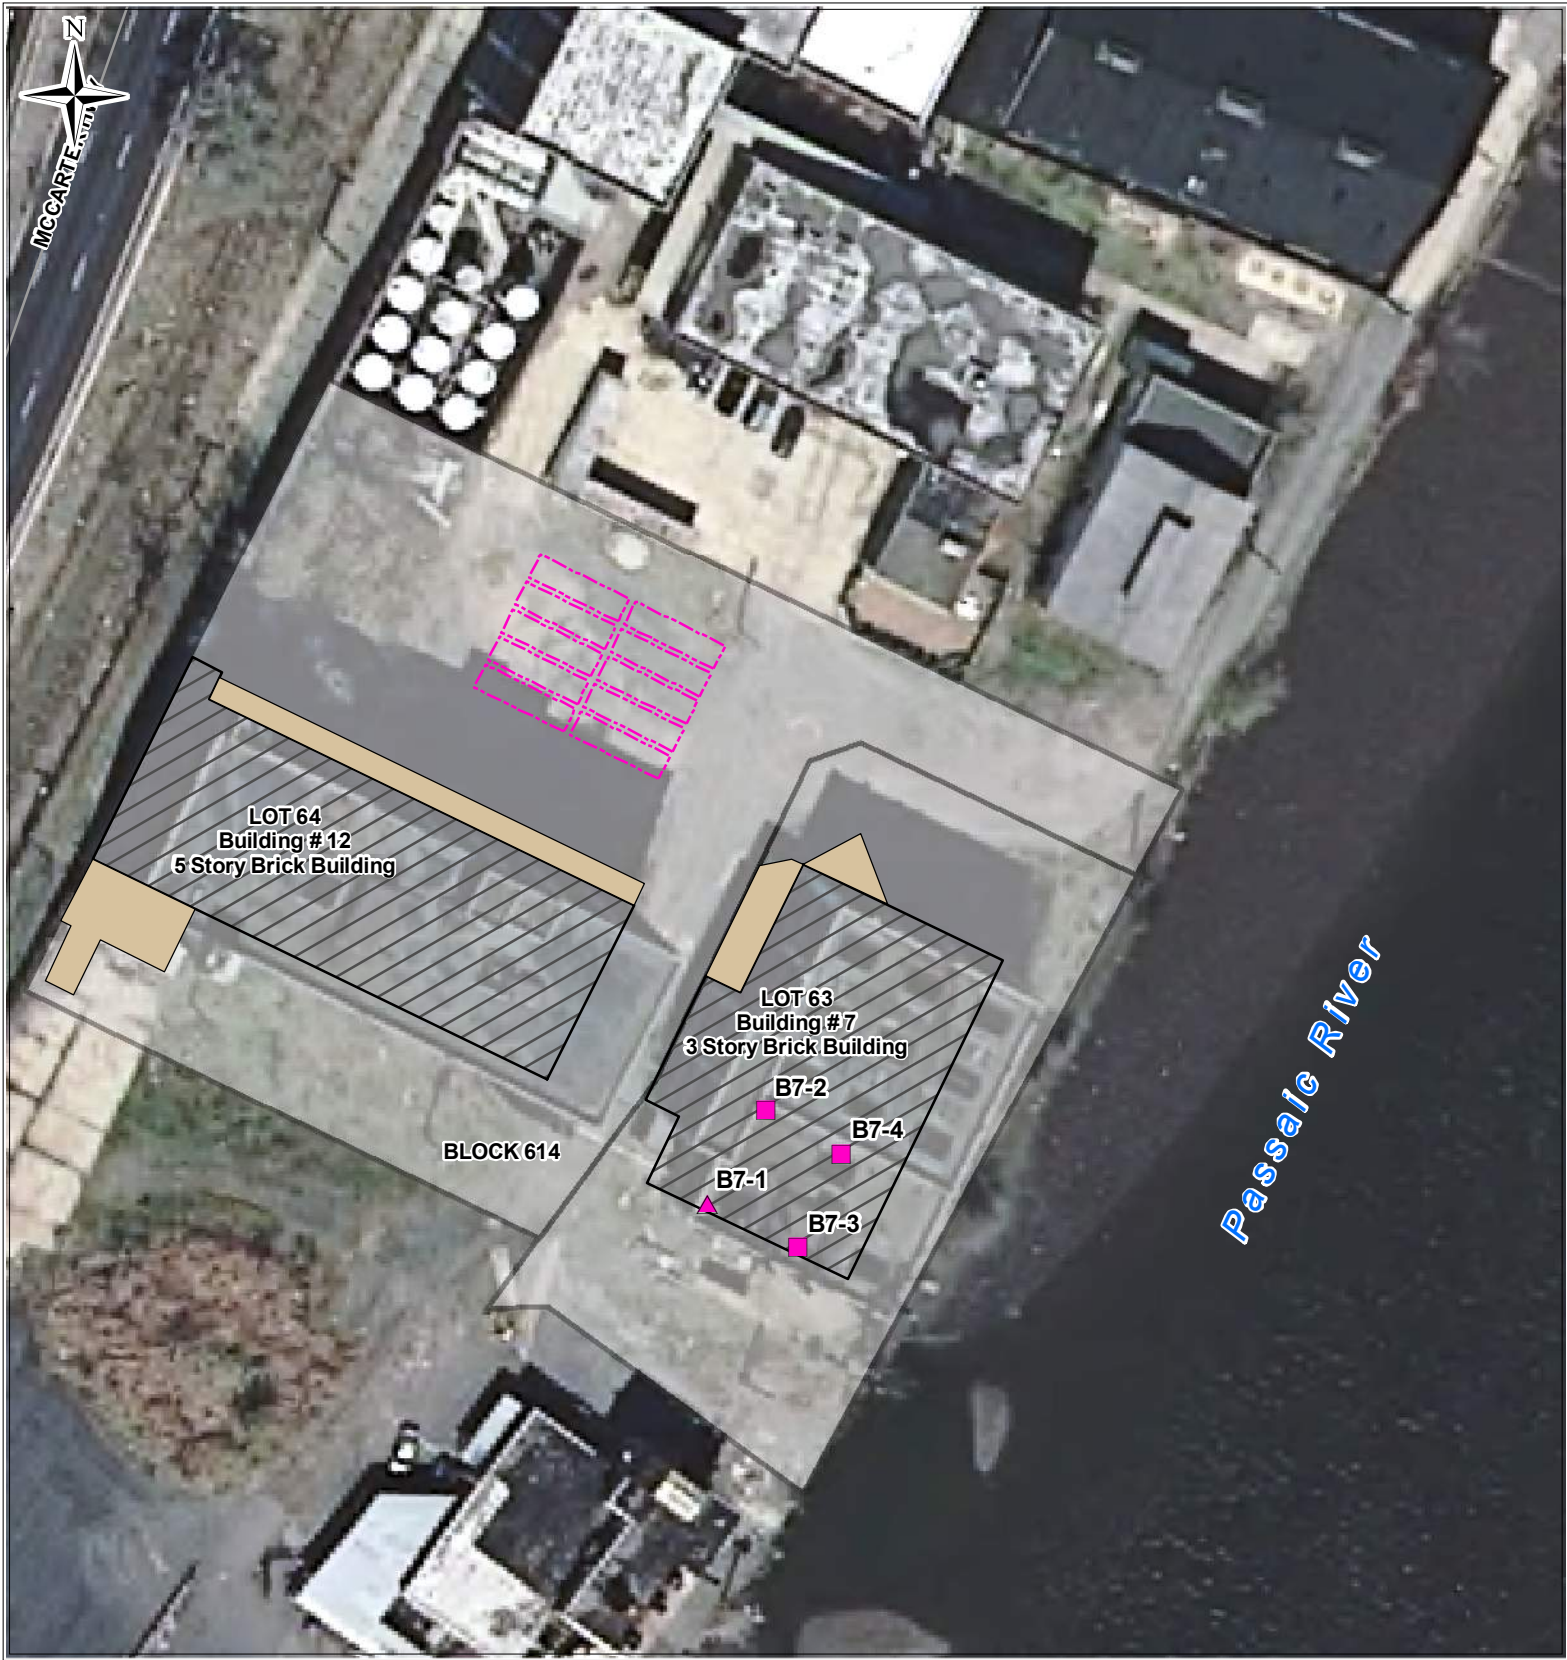
Figure 7
VOC & SVOC Results In Sediment From Building 7
29 Riverside Ave. (Phase 2 Assessment)
Newark, New Jersey

Analyte	Concentration (µg/kg)	
	B7-1	
Acetone (1,000,000/100,000)	1,200	
Benzene (13,000/1,000)	1,400	
2-Butanone (1,000,000/50,000)	1,000	
Carbon Disulfide	87	J
Chlorobenzene (680,000/1,000)	650	L
1,1-Dichloroethane (1,000,000/10,000)	140	J
1,1-Dichloroethene (150,000/10,000)	28	J
1,4-Dichlorobenzene (10,000,000/100,000)	2,100	J
1,2,4-Trichlorobenzene (1,200,000/100,000)	120	J
1,2,3-Trichlorobenzene	15	J
1,1,2-Trichloro-1,2,2-Trifluoroethane	22	J
1,1,1-Trichloroethane (1,000,000/50,000)	2,500	
Chloroform (28,000/1,000)	150	J
Cyclohexane	37	J
Ethylbenzene (1,000,000/100,000)	11,000	L
Isopropylbenzene	2,500	L
Methylene Chloride (210,000/1,000)	740	
Methylcyclohexane	120	J
4-Methyl-2-Pentanone	320	L
M+P-Xylene (1,000,000/67,000)*	11,000	L
O-Xylene (1,000,000/67,000)*	7,900	L
Styrene (97,000/100,000)	11,000	L
Trichloroethene (54,000/1,000)	34	J
Tetrachloroethene (6,000/1,000)	830	L
Toluene (1,000,000/500,000)	38,000	L

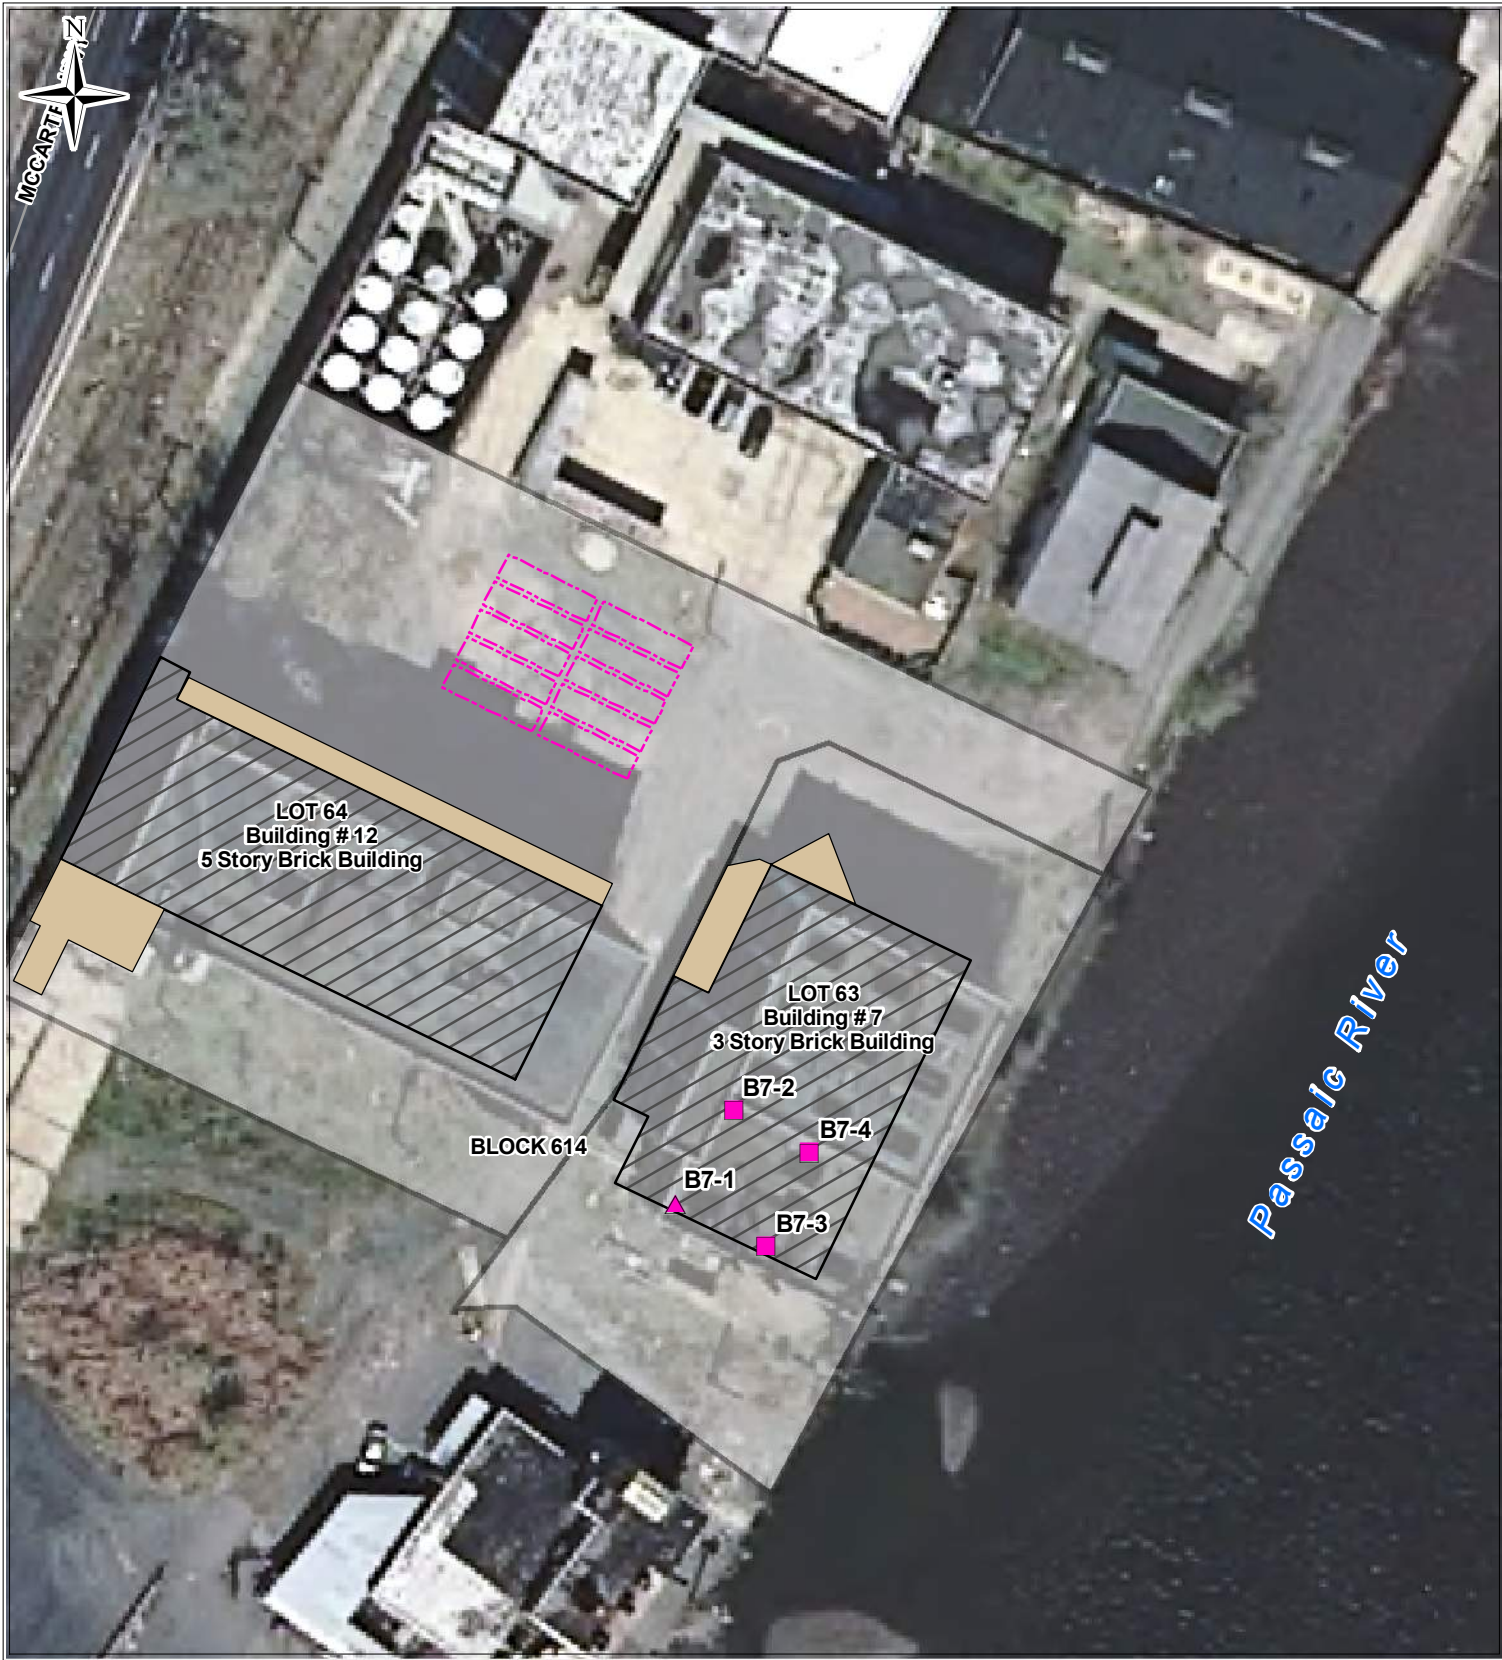
Figure 8
VOC & SVOC Results In Water From Building 7
29 Riverside Ave. (Phase 2 Assessment)
Newark, New Jersey

Analyte	Concentration µg/L							
	B7-1		B7-2		B7-3		B7-4	
Acetone (6000)					620	K	530	K
Benzene (1)	15	L	7.6	L	26		12	
2-Butanone	500	K	460	K	590	K	480	K
1,1-Dichloroethane (50)	59	L	37	L	76		37	
1,2-Dichlorobenzene (600)	13	J	15	J	19		11	
1,4-Dichlorobenzene (75)			6.5	J				
1,2,4-Trichlorobenzene (9)	51	J	62	J	49		34	
1,2,3-Trichlorobenzene	14	J	14	J	12		9.4	
1,1,1-Trichloroethane (30)	150	L	100	L	580		250	
Chlorobenzene (50)							21	
Chloroform (70)	78	L	46	L	210		76	
Cyclohexane					10		5.6	
Ethylbenzene (700)	130	J	100	J	95		84	
Isopropylbenzene	6	J	5.5	J	6			
Methylene Chloride (3)	940		560		1,000		600	
Methylcyclohexane	0.12	J			14		7.2	
4-Methyl-2-Pentanone	95	J	45	J	75		47	
m-P-Xylene (1000)*	43	J	31	J	190		77	
O-Xylene (1000)*	31	J	23	J	200		86	
Styrene (100)	27	J	19	J	65		25	
Trichloroethene (1)	6	L			75		24	
Tetrachloroethene (1)	7	J			49	J	15	J
Toluene (600)	180	J	110	J	910		530	
Benzene,1,2,3-Trimethyl	42	NJ	60	NJ	71	NJ	61	NJ
